Monitoring DATA collected by: M. Green and J. Young Date: 9/12/11

UT to Dixon Branch

Site 19

Year 3 Summer – September 2011

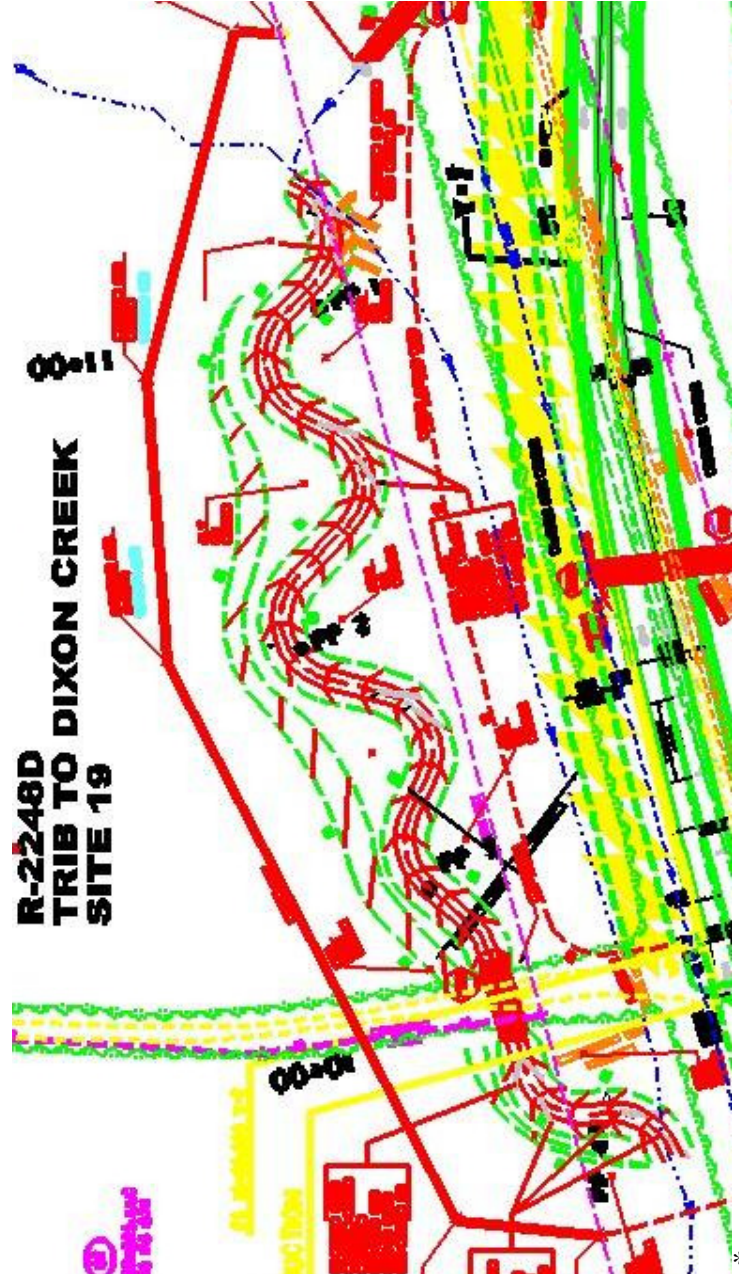
UT to Dixon Branch (Site 19) stream relocation is stable for the Year 3 Summer evaluation, except for, some areas of bank scouring that were noted previously upstream of the pipe crossing at Sta. 10+80 Y-7 and Sta. 10+40 Y-7. NCDOT has installed live stakes along the streambank to help stabilize these areas of scouring behind these J-hooks. The areas of bank scouring show little or no changes since the last evaluation. The area downstream of the pipe that had extensive erosion was repaired during May 2010. Evidence of a bankfull event has been noted since last monitoring evaluation. NCDOT will continue to monitor channel stability at this stream relocation.

Left bank scouring at end of J-Hook @ Sta. 10+40 Y-7
